Evaluation of Vialit Asphalt's *Rephalt* Cold Mix Patching Material

Report Origin: Todd M. Rorrer
Assistant Asphalt Program Manager

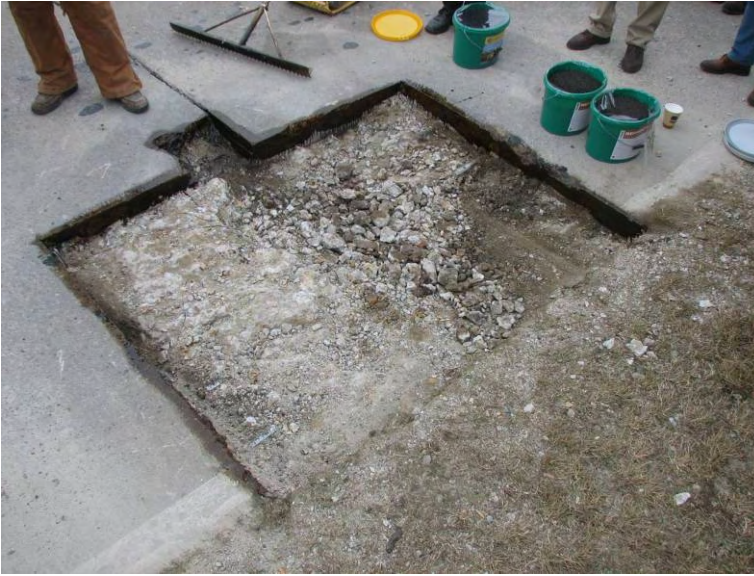
The existing distressed material was removed down to sound concrete.

The leading half of the patch was found to be sound at a depth of approximately 5 to 6 inches (127 to 152.4 mm).

The trailing half of the patch was deteriorated down to the sub-grade in the center of the patch.

The excavated patch was cleaned and blown free of loose debris, the deepest distressed portion was seated with a vibratory plate compactor.

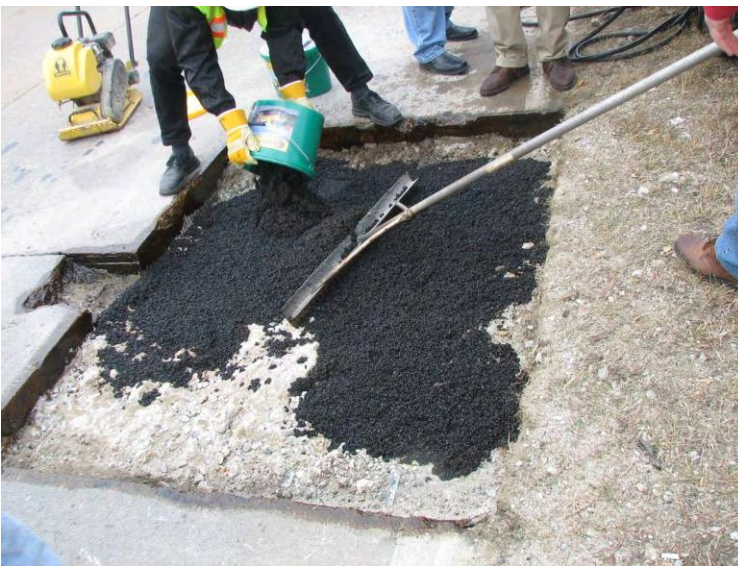
Rephalt 0/4mm material was used as a leveling and consolidating course for the deepest section of the excavation.

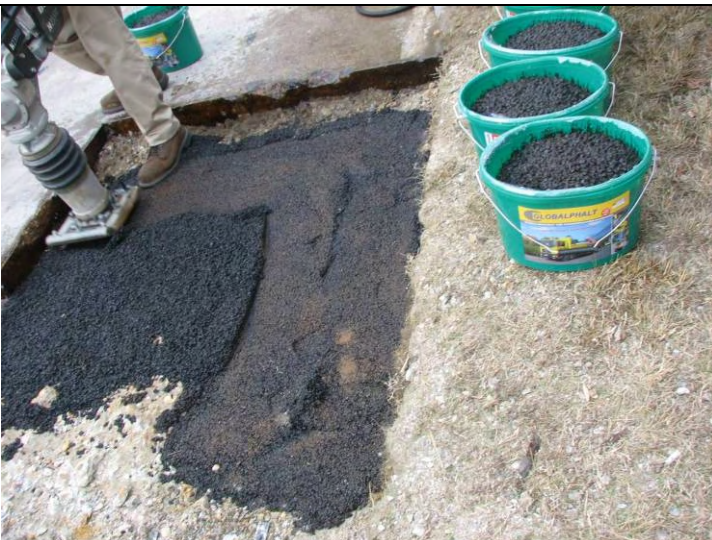
0/4mm mix compacted using a 'jumping jack' compactor

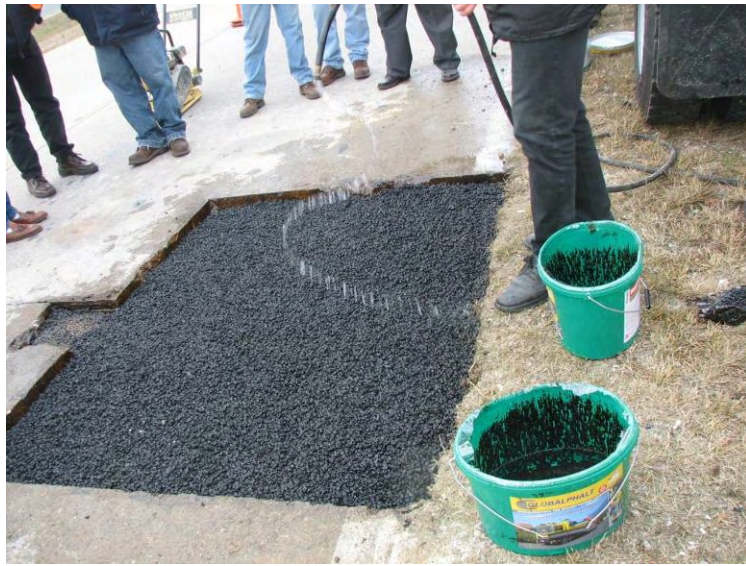
Two lifts 0/11mm mix were used as base and binder layers.

The 'jumping jack' compactor was used for compaction on all layers lower than the final surface

Approximately 1 liter of water was added to each 25kg bucket before placement and an additional liter was "sprinkled" on the loose material before compaction.

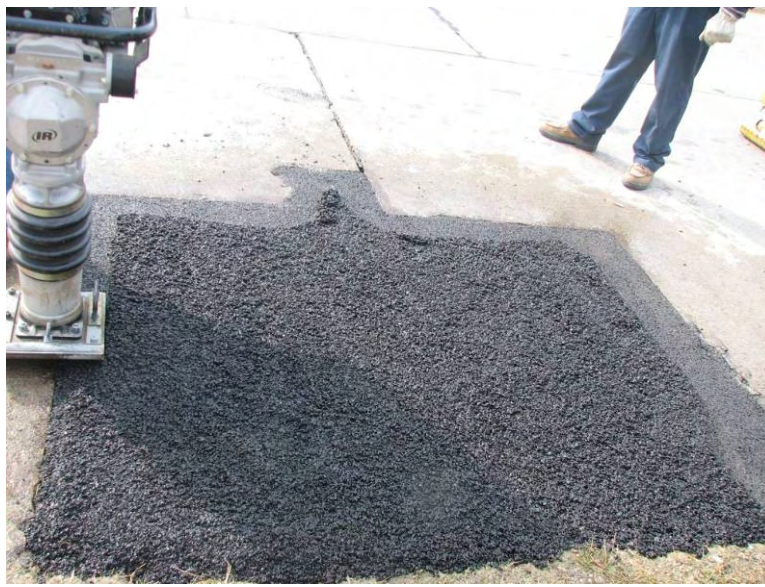
A final 0/8mm lift was placed for the final riding surface of the patch.

Edges were pinched with the 'jumping jack' compactor.

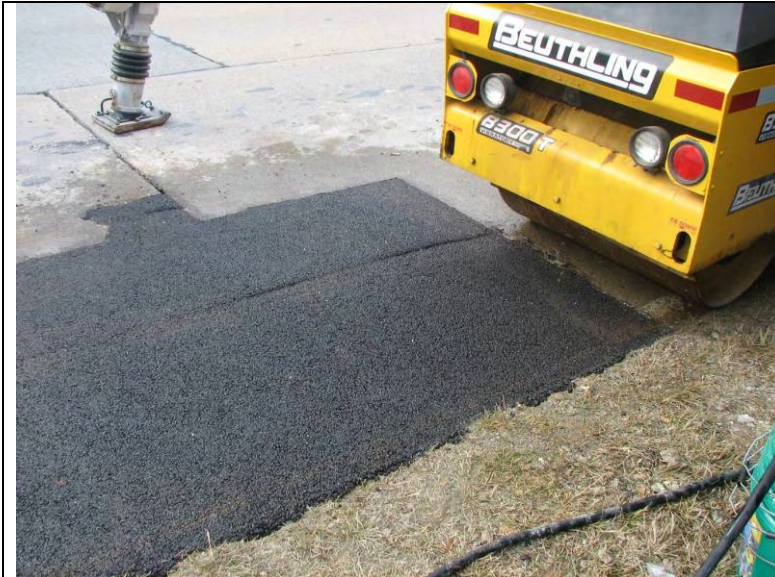
A small roller was used with vibratory and static passes to achieve final compactive effort and achieve a smooth uniform surface

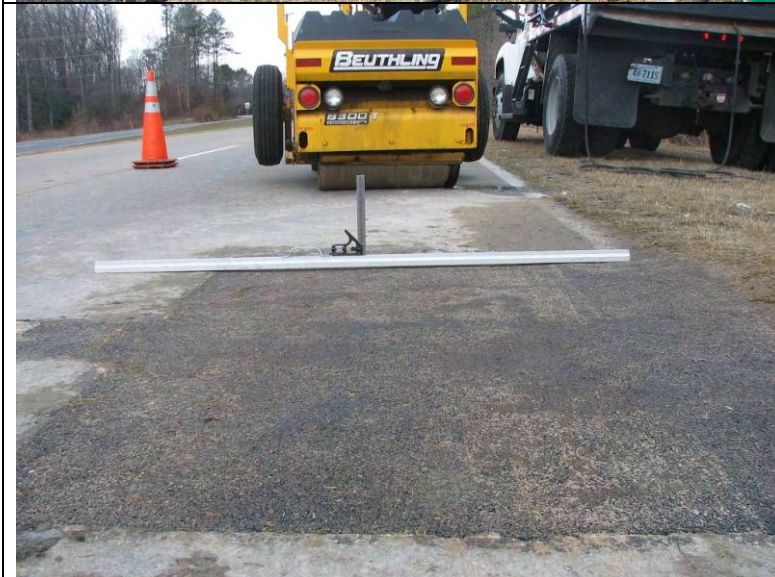
The final surface was slightly high to the right and center of the patch.

The Rephalt material did not exhibit any quantifiable distress in these five categories. There was slight pushing in one quadrant of the patch; this was most likely due to the patch being high on the center of the right edge during construction. The distortion in the patch was just noticeable to the eye and was not measurable.

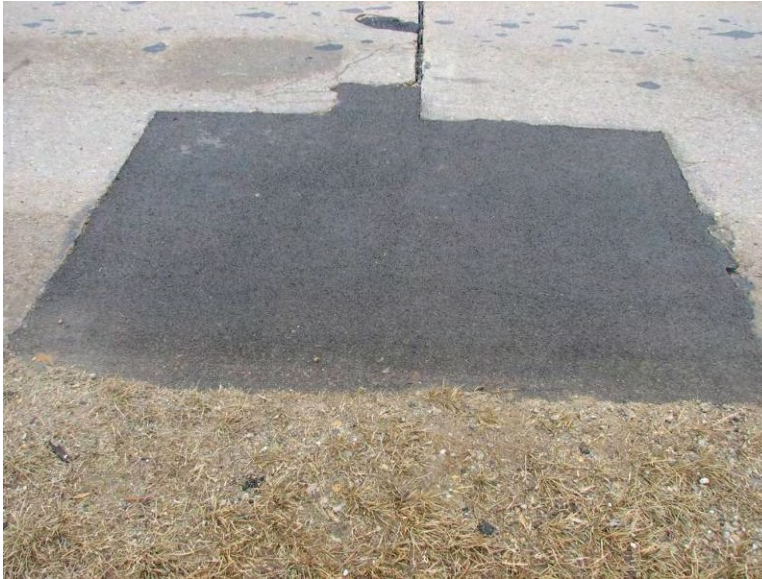
Figure 4, evaluation site after one week of service

The site was visited routinely in the first two to three weeks of service, to ensure the material stiffened adequately with the reaction to the added water. The site was inspected monthly thereafter. There have been no signs of pushing, shoving or rutting in the patch; distresses that would be associated with a weak or unstable mix.

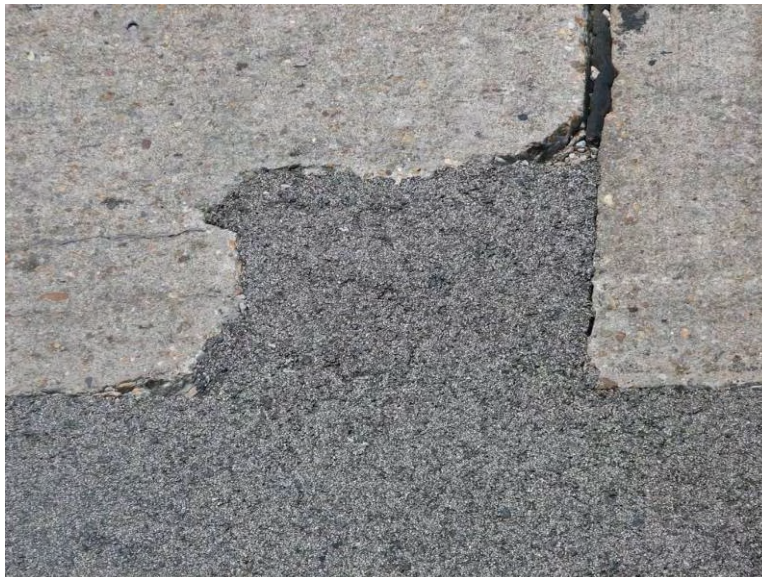
Material is in-place, stable and shows no signs of cracking

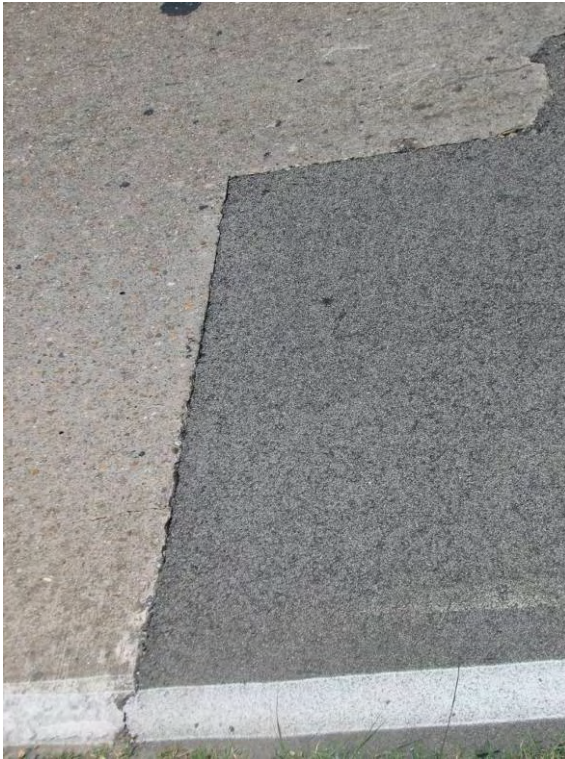
Material has maintained a uniform profile, very little to no pushing or shoving and no rutting

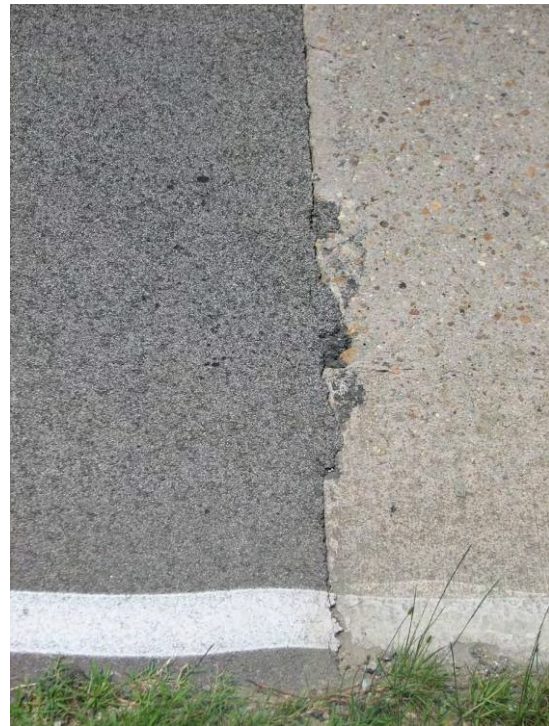
Tight joints have been maintained, material has not bled, or streaked away from the patch
